### **APPENDIX**

1.	Abstract	
2.	Material Investigation	1
	Element & Material Matrix	
4.	Proposed Ferry Routes in French Polynesia	13
5.	Cost Comparison	14
6.	Outreach, Champions, and Partners	15
	Trip Summary - March 31 <sup>st</sup> , 2007	
8.	Field Notes	20
RE	EFERENCES	29

### 2. Material Investigation

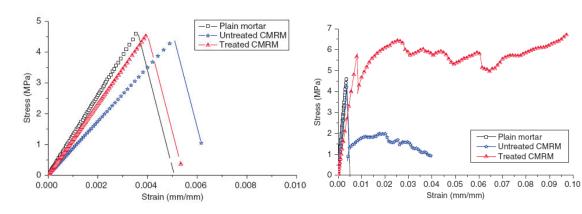
Fig 5. Stress-strain curve of **0.6%** CMRM and control specimen.[2]

Fig 6. Stress-strain curve of **1.2%** CMRM and control specimen.[2]

Coir fiber both as a mesh or individual fibers has been shown to dramatically increase the performance of composite materials [2, 3]. Stress-strain curves for the differing percentages of fiber mesh are presented in Figures 5 and 6. The control specimen has no toughening effect, whereas the use of the fiber mesh reveals significant toughening, which also correlates to higher energy absorption. The CMRM composites also recorded a 40% increase in flexural stress, 25 times improvement in flexural toughness and a higher toughness index [2]. Multi-layer meshes have been shown to have increased performance compared to single layer performance. A direct comparison of individual fibers versus fiber meshes has not been conducted, but the same positive attributes are found in both system.

Potential challenges of coir fibers are durability and bonding. The alkaline media of cement acts to weaken coir fibers; however, these fibers were found to perform superior to numerous other fibers due to their low water absorption [3]. To improve long term durability, and hence performance, of coir fibers a reduction of the alkalinity of the matrix should be pursued. Finally, concerns over the transition zone between the fiber and cement matrix seek to improve the quality of bond between the two materials. Through the use of wetting agent the fibers are able to better bond to the matrix and hence perform more favorably (see Figure 5 and 6) [2].

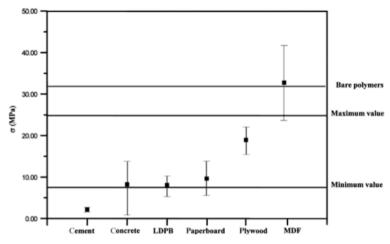
Figure 7 – Limits of Strength as Compared to Common Building Materials [4]

Several mix designs were analyzed in the process of evaluating the potential capability of the panel for construction use. Mainly, the polymer blend, the amount of carbon black and magnesium hydroxide were varied to select the optimal mix. Flexural and compression strength tests were conducted on the various mixes for assessment. The maximum, minimum and average ranges of test results were compared with common construction materials currently used for interior paneling. The results are contained within the graph below:

As illustrated by the Figure 7, the strength range is comparable to other commonly used building materials. Also, by testing it was shown that PP + PE blends had the best mechanical properties and also that limiting the additive amounts improved them as well.
